Allied Paper, Inc./Portage Creek/Kalamazoo River Superfund Site

Plainwell No. 2 Dam Area Reconnaissance Photographs

November 20, 2008

A compilation of photographs taken by Mike Erickson of ARCADIS and Sam Borries of USEPA

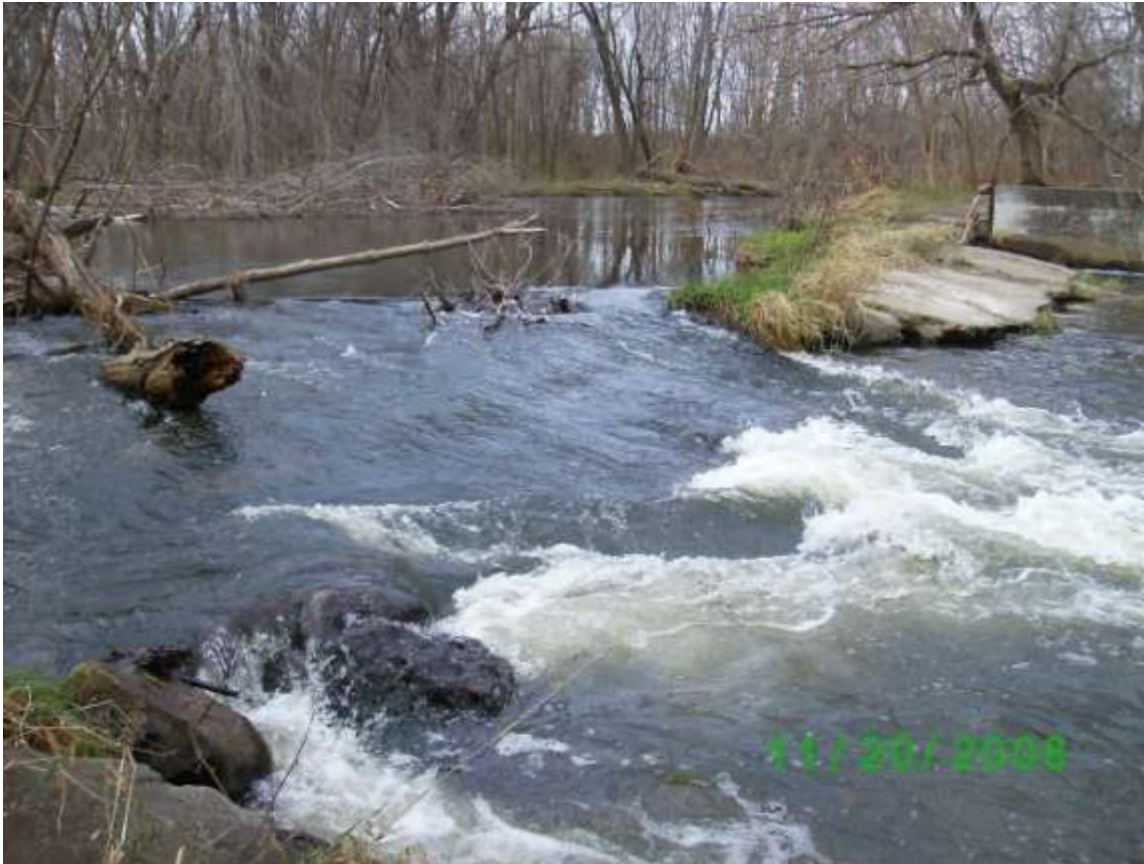
Left diversion structure.

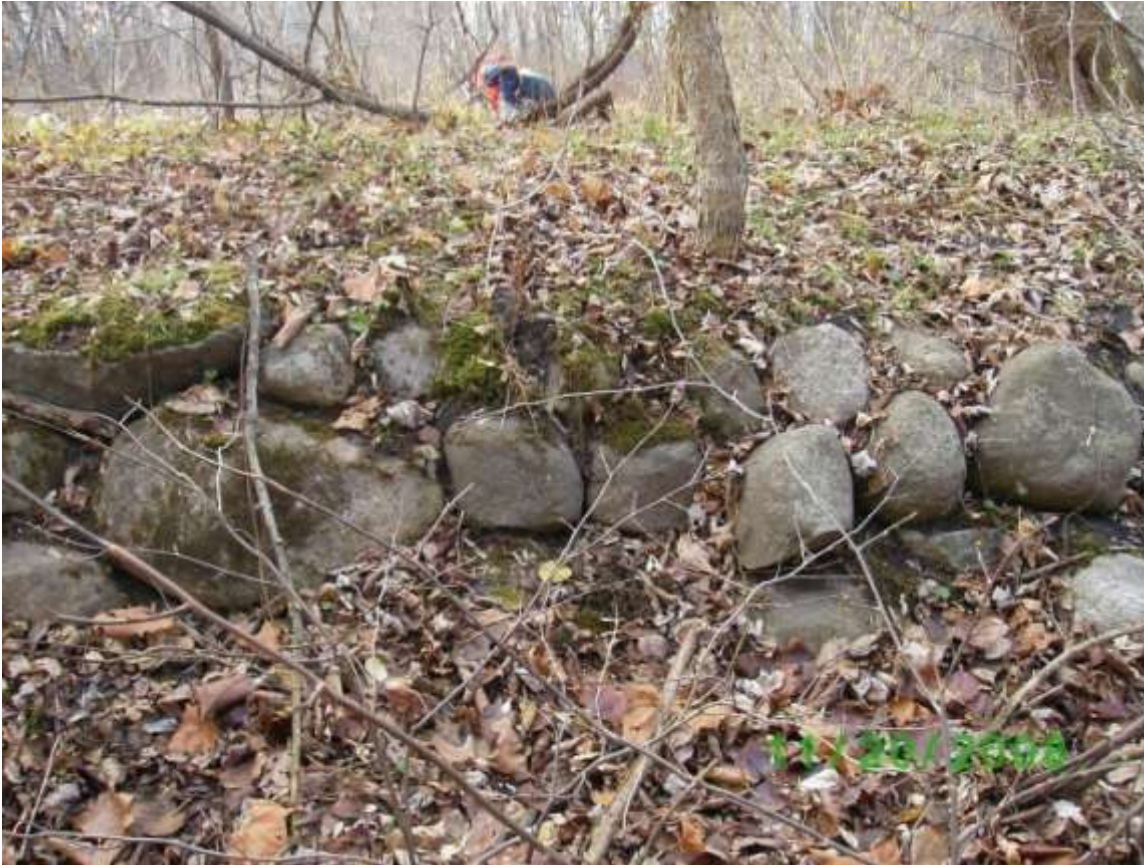
Downstream side of berm between right and left diversion structure.

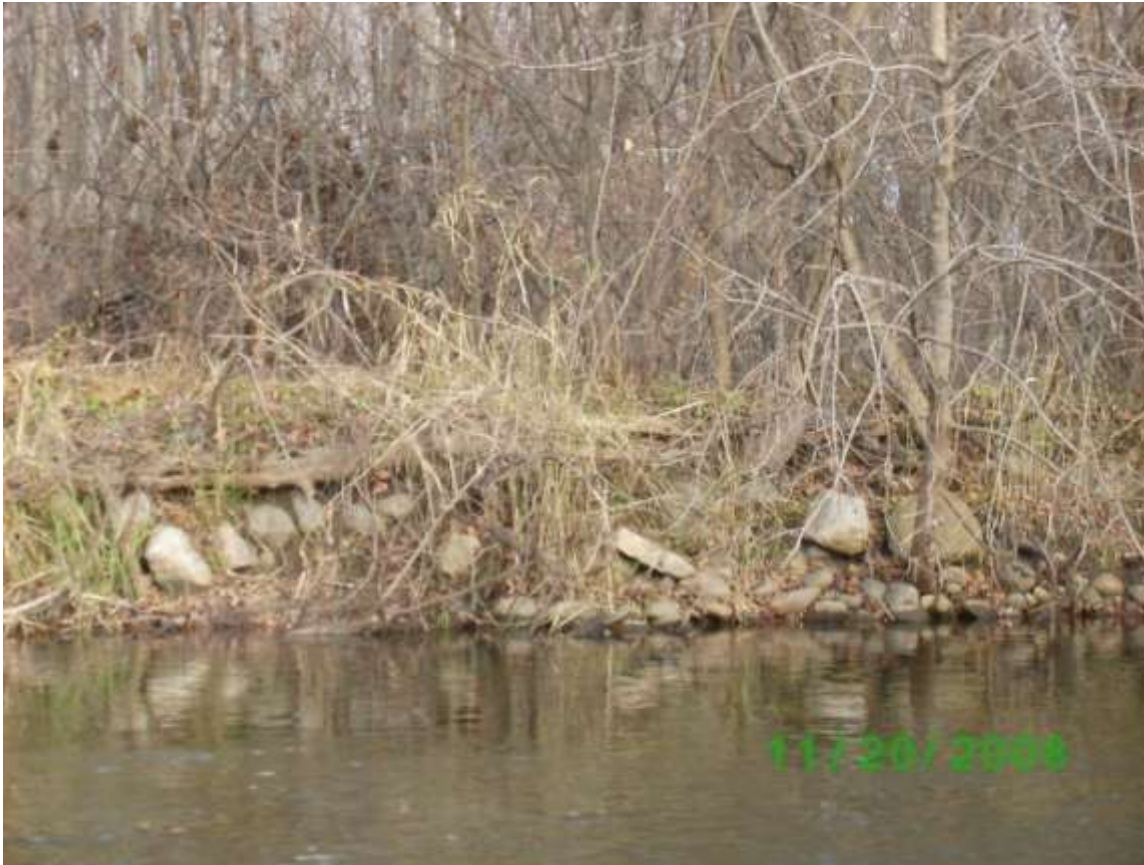
Upstream side of berm between left and right diversion structures.

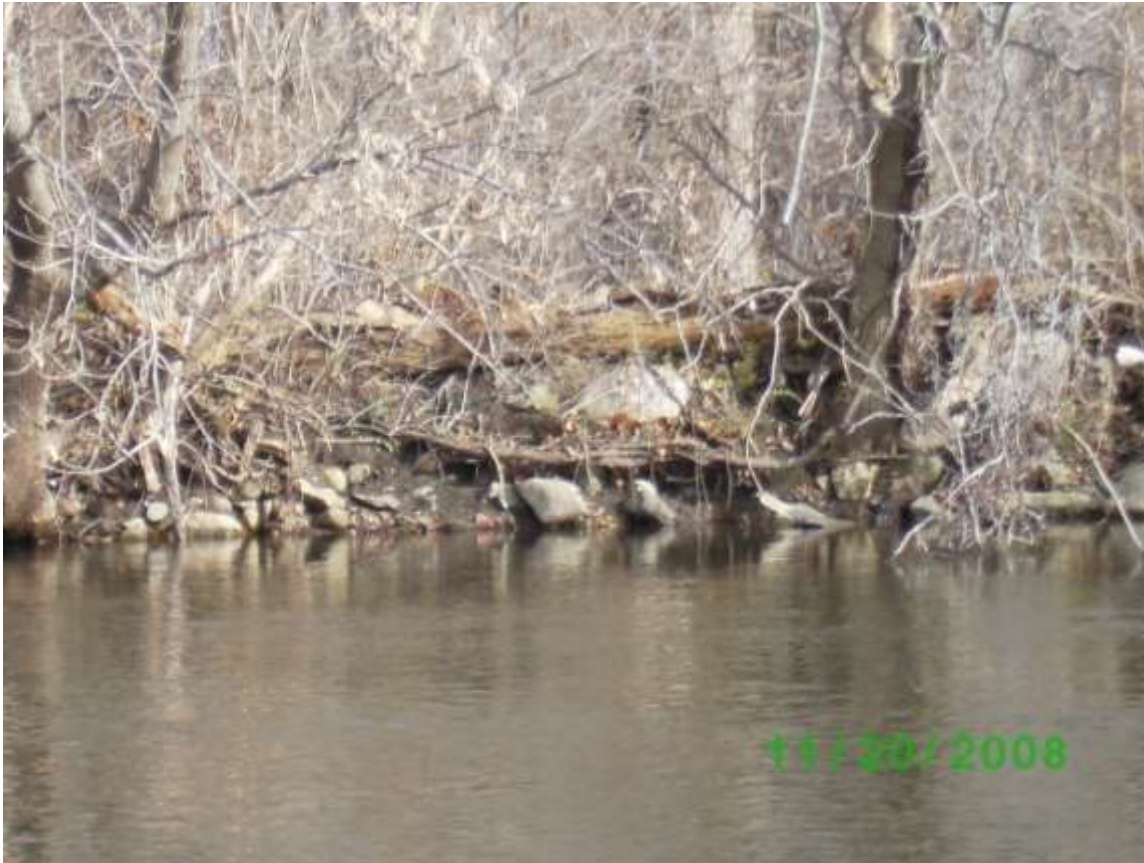
Upstream side of berm between left and right diversion structures.

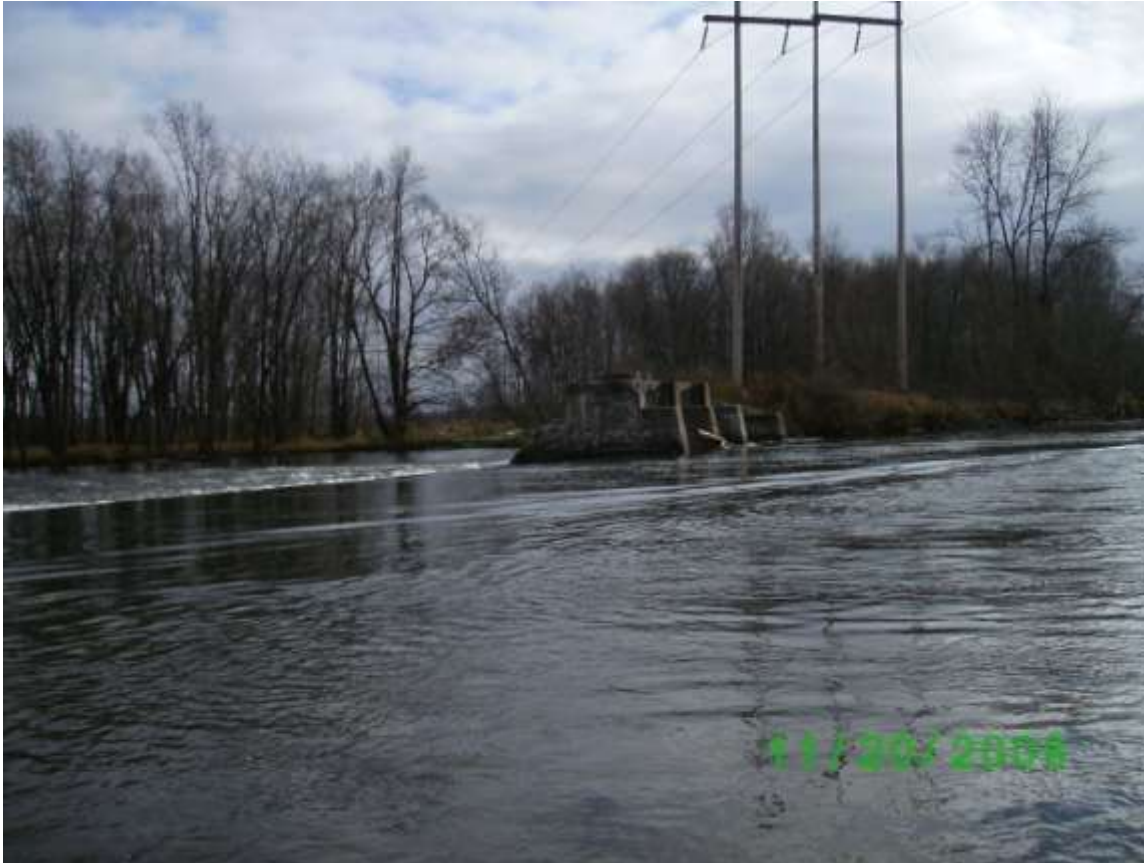
Right diversion structure.

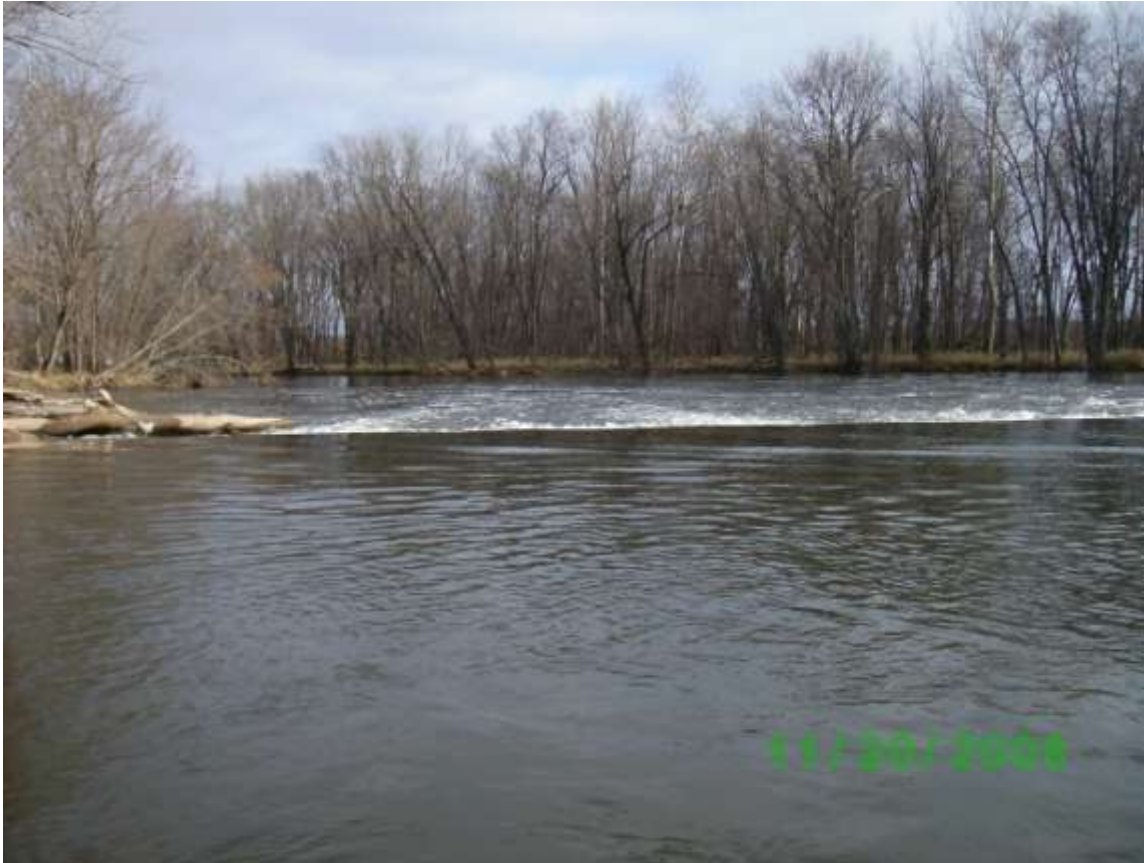
Right diversion structure.

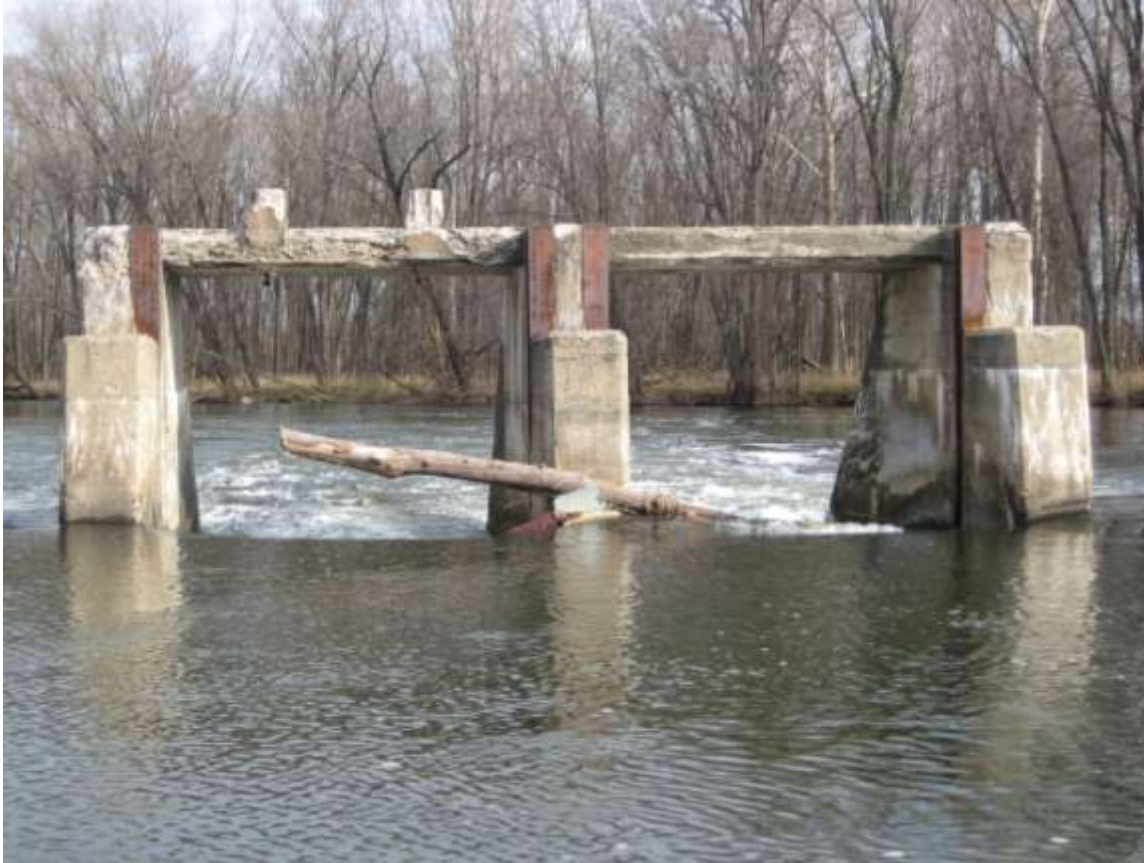
Right diversion structure flow gates.

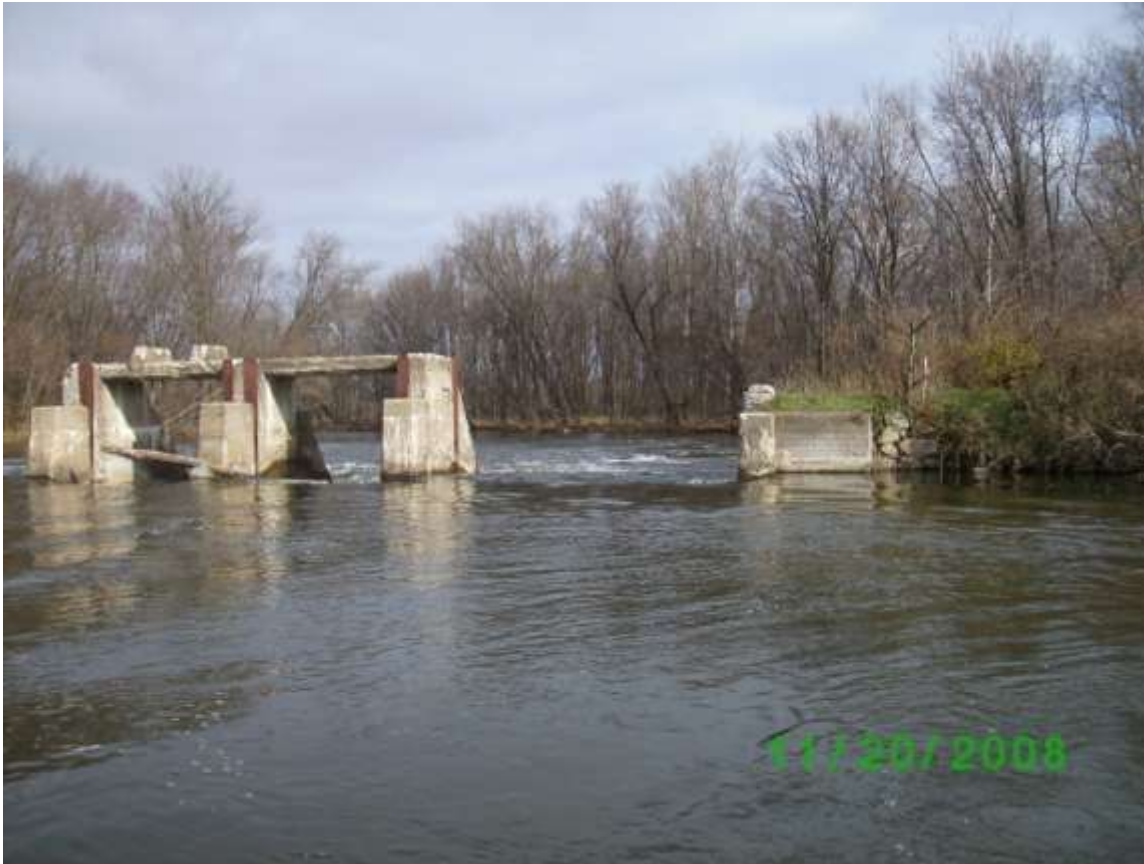
Right bank and flow gates at right diversion structure.

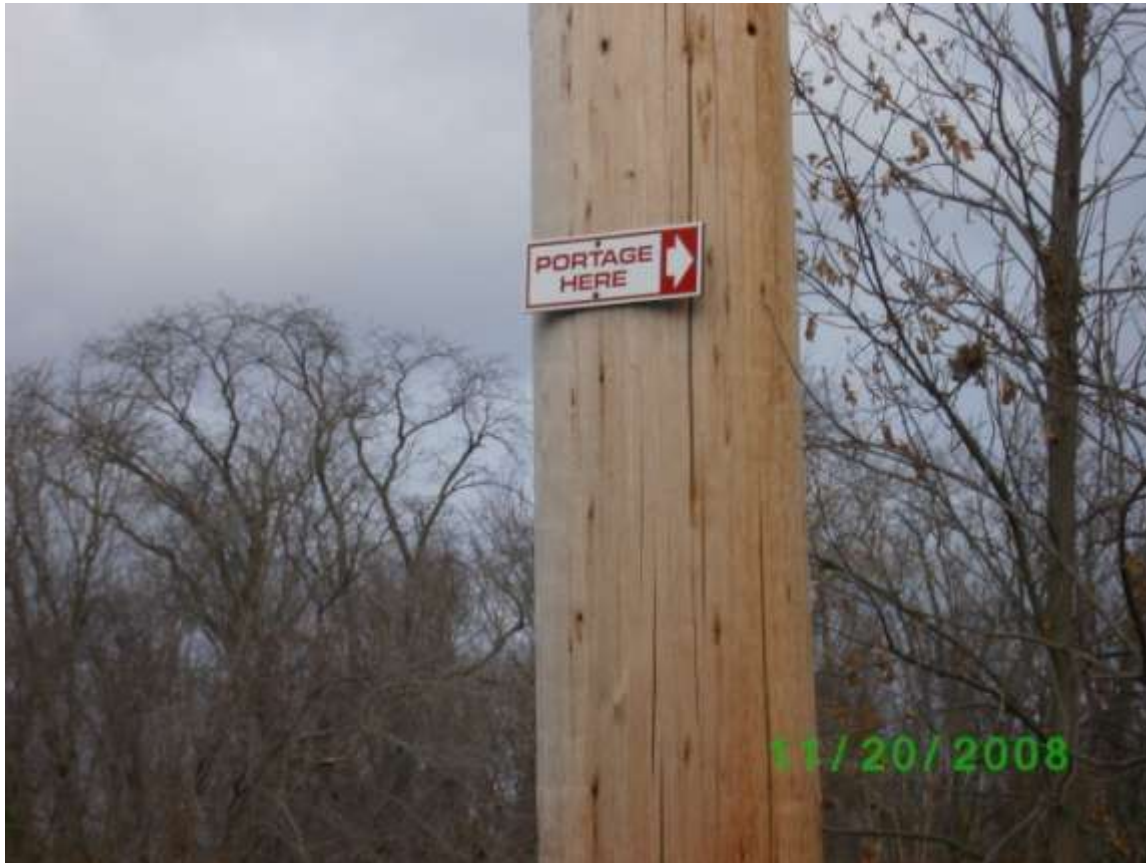
Small hard-to-notice portage path sign.

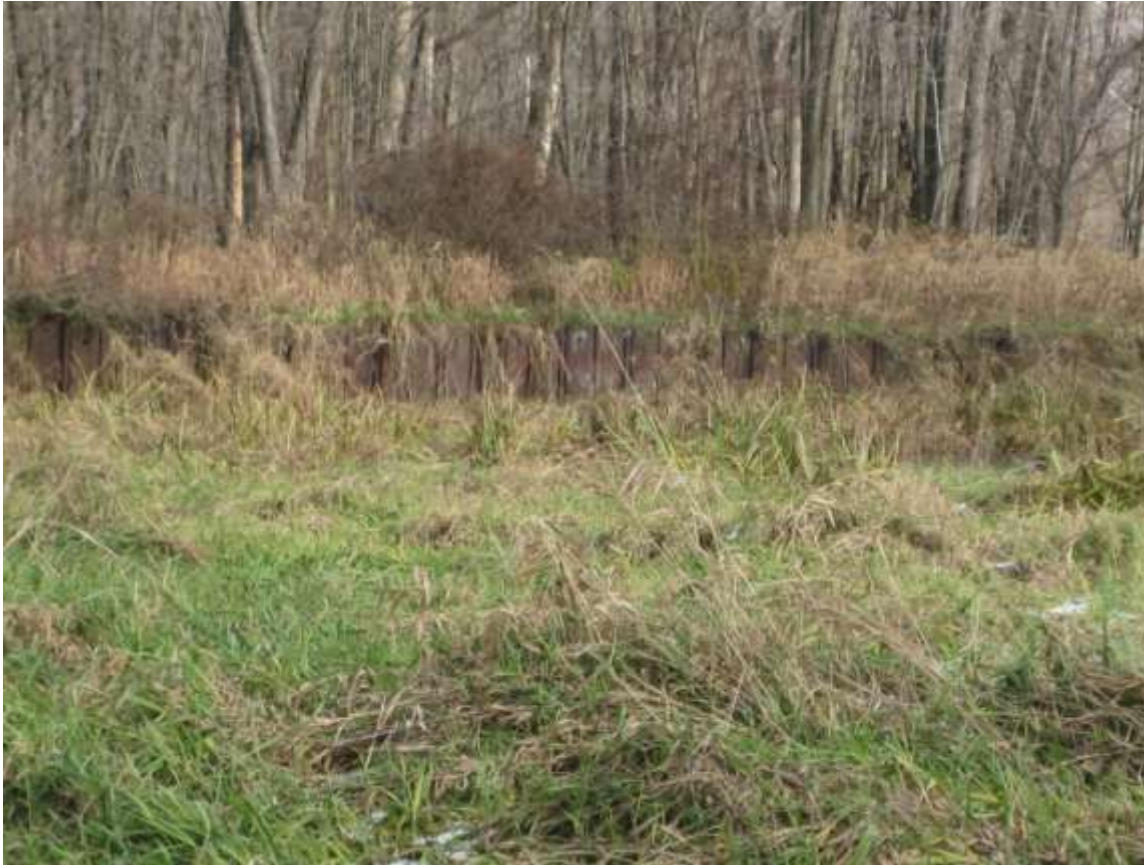
Sheet pile wall along upstream side of earthen berm to north east of right diversion structure.

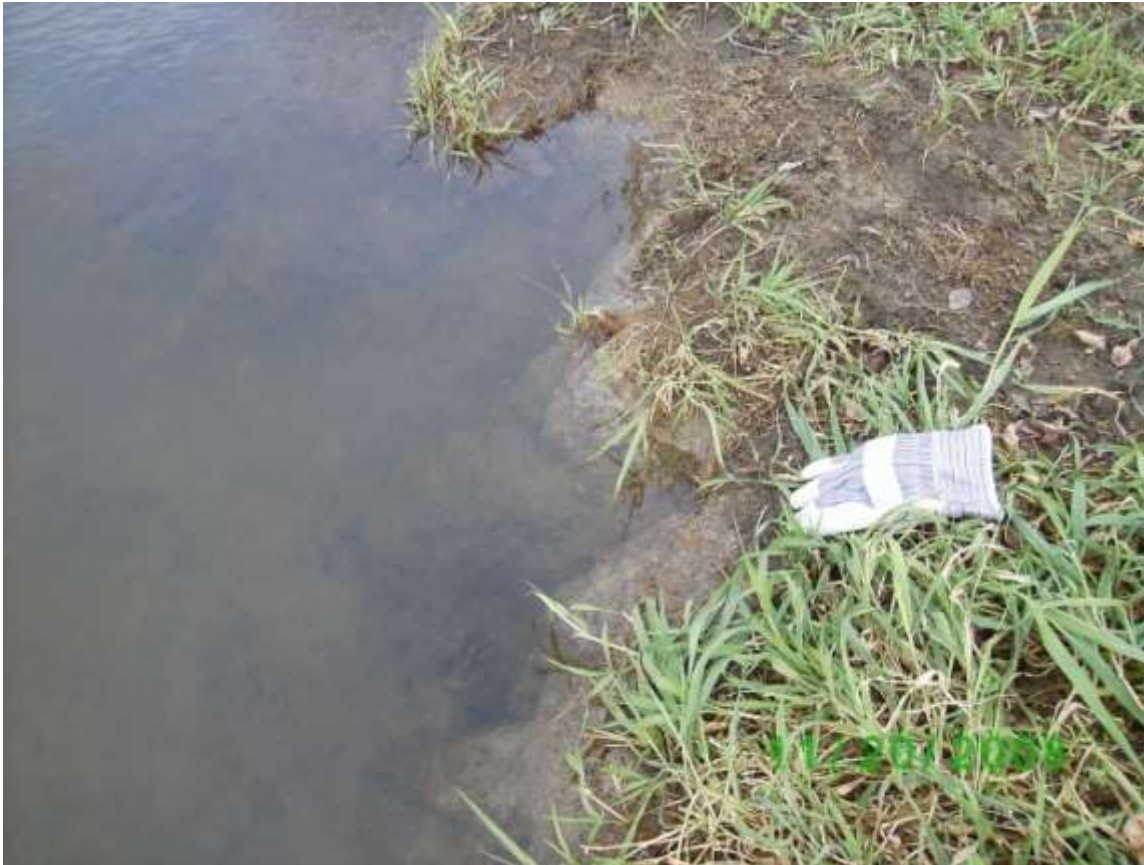
Bank soils upstream of right diversion structure on north bank.

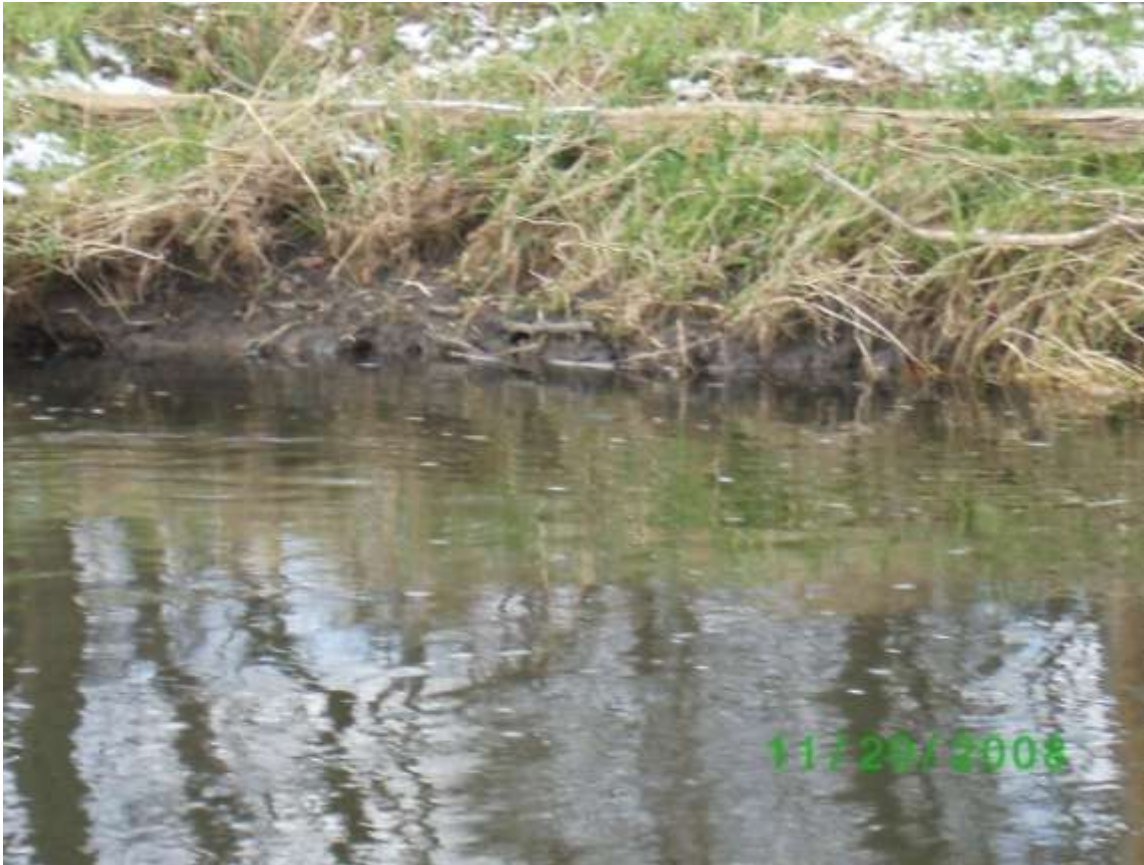
Bank soils along south bank downstream of mouth of oxbow.

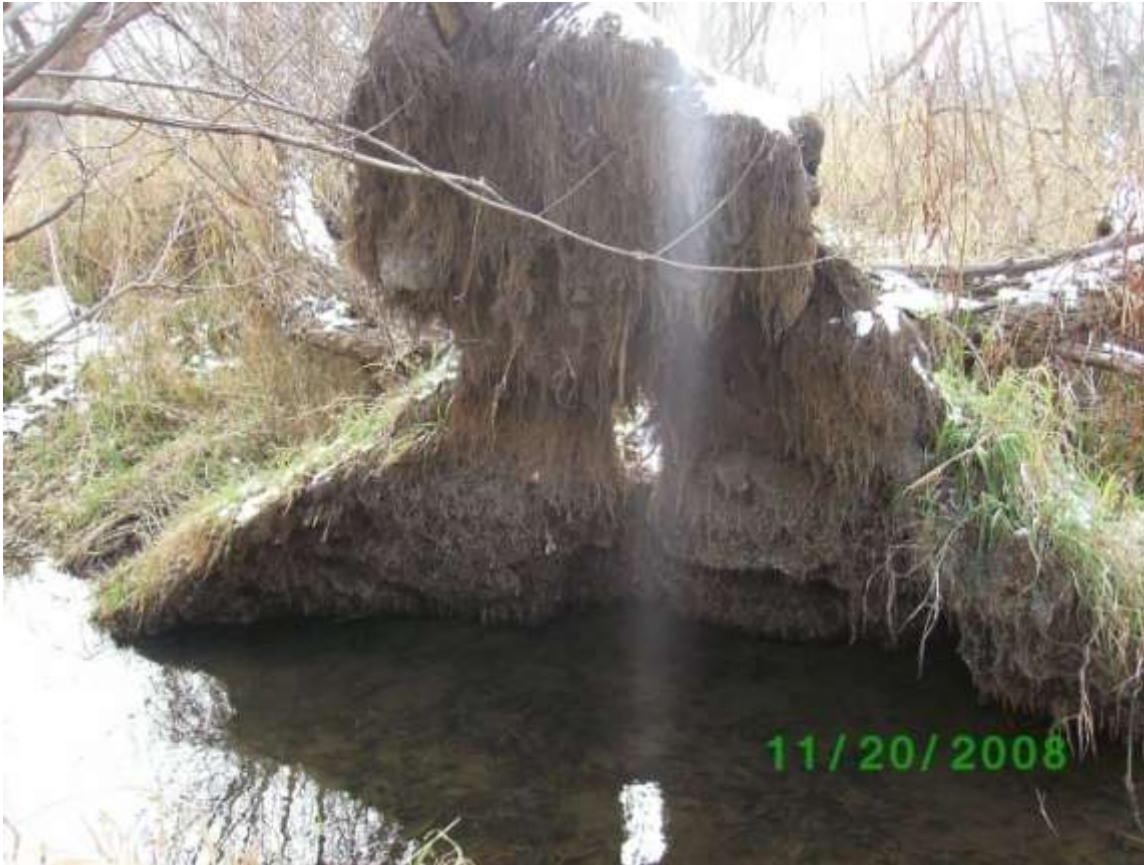
Tree root mass at mouth of oxbow.

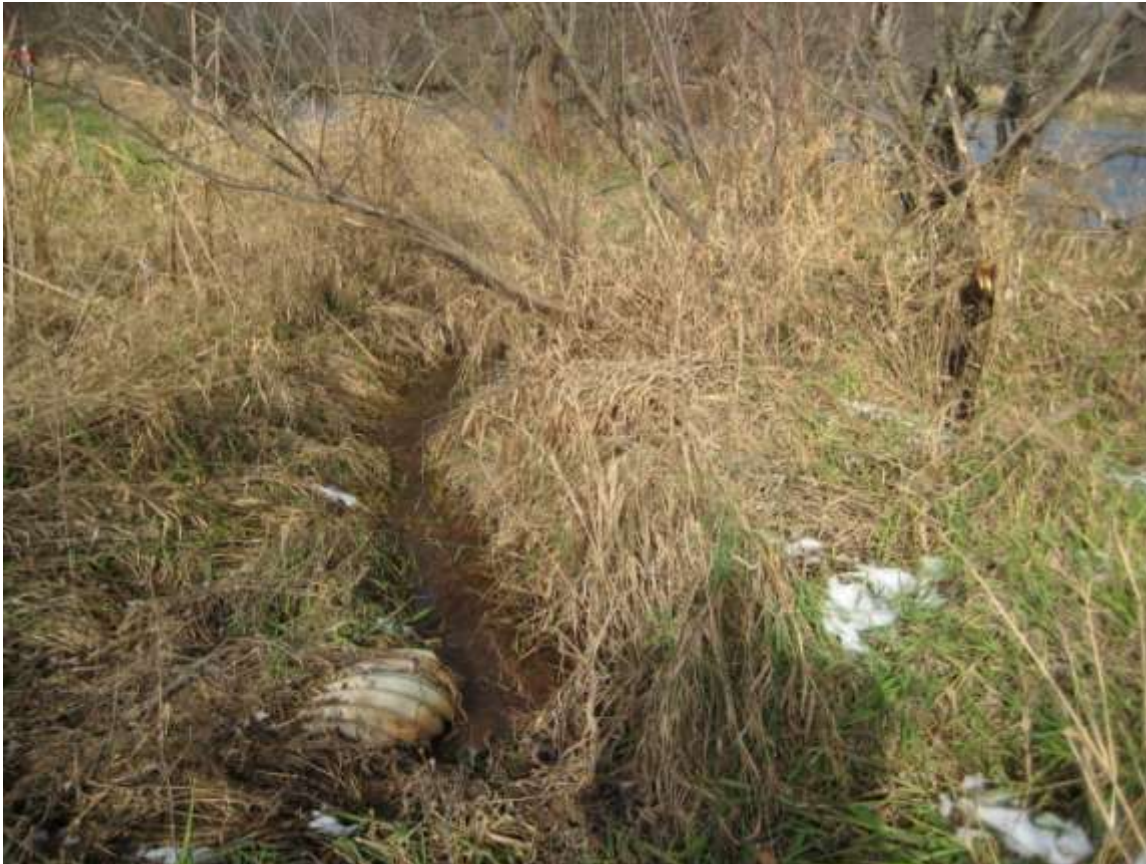
Culvert draining marsh enclosed by oxbow.

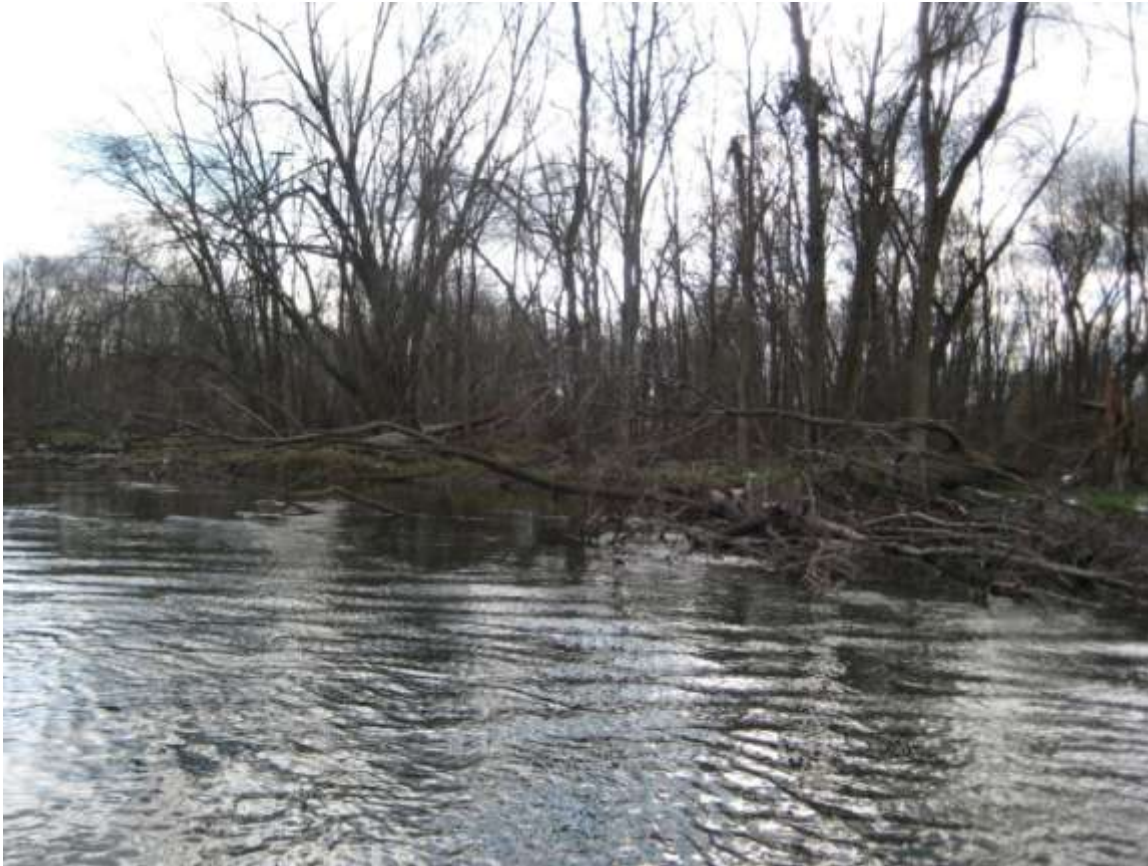
Near upstream end of oxbow (former entrance to oxbow channel not visible at any location along bank, or indicated by variation in tree cover).

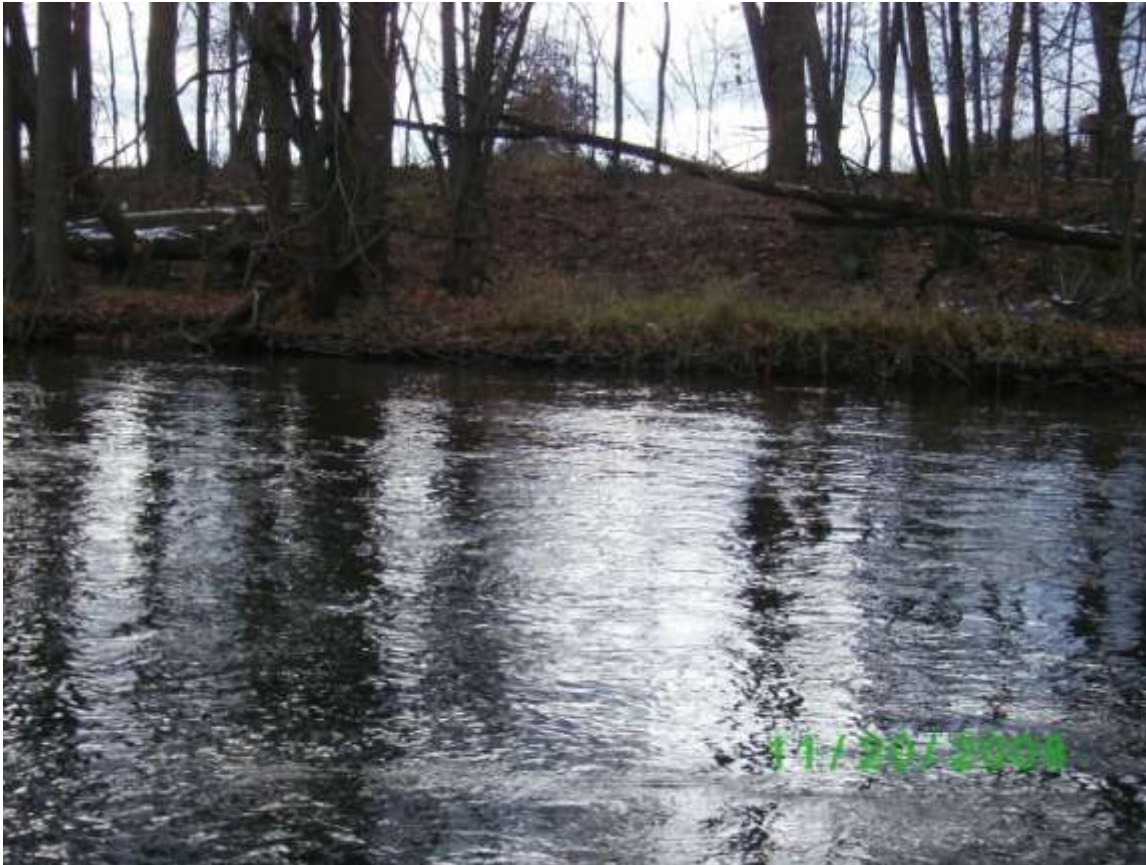
Steep slope on south bank.

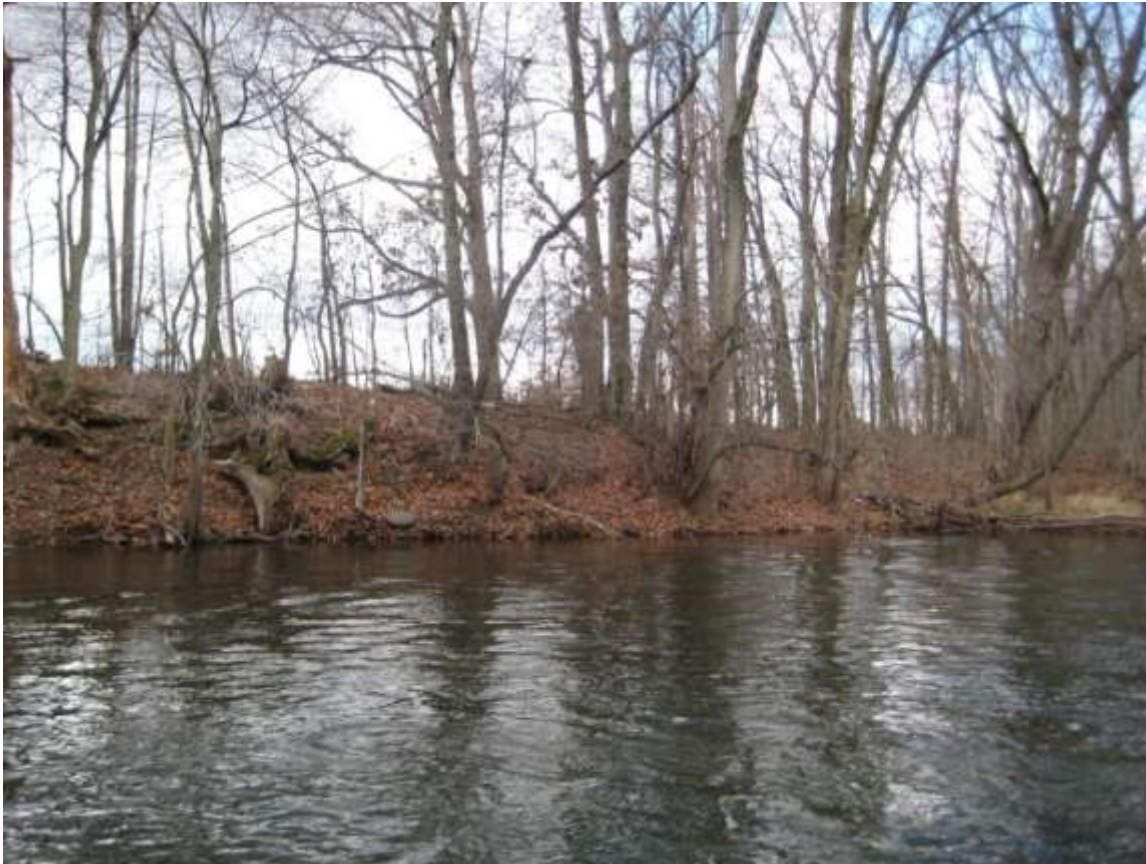
Steep slope on south bank.
